## HIGH EFFICIENCY BAND SCREENS TRIPLES SCREENING CAPTURE FOR GORDONVALE STP

CASE STUDY

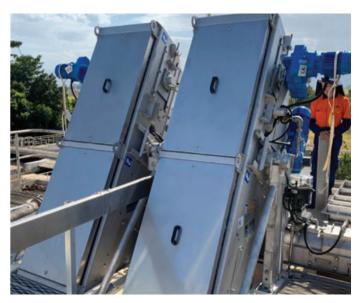
HUBER Escamax is a through flow band screen uses a perforated band to remove solids and screenings from sewage.

The perforations capture a high amount of material as compared to the existing units which were bar screens. The geometry of the screen allows for an easy retrofit into the existing channels.

Item	Value
Screen Type	Through Flow Band Screen
Aperture	6mm perforations
No of Screens	Two
Capacity Per Screen	187 L/s
Screenings Capture	84%
