MODERN SCREENING FACILITY PROTECTS NARRANDERA STP

CASE STUDY

Hydroflux was chosen to deliver a contract that involved designing and installing screenings removal and washing technology at the Narrandera Sewage Treatment Plant (STP).

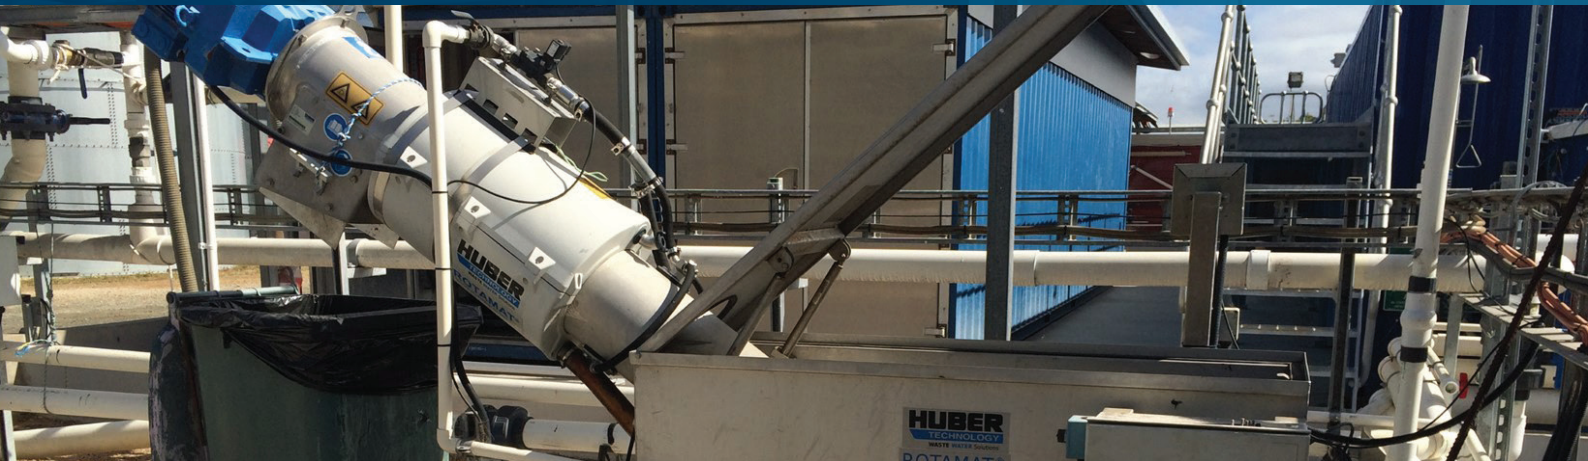
The technology installed is a HUBER Ro9 Inclined Spiral

Screen, one of the range of high-quality German-manufactured screens designed specifically for smaller sewage treatment plants of up to 5ML/day. In this instance, it was sized for 215 L/s of peak flow.

The ROTAMAT® Micro Strainer Ro 9 operation is based upon a unique system that allows a combination of screening, washing, transport, compaction and dewatering in a single unit.

It removes gross solids from the raw sewage, thereby protecting the facility from accumulation of solids, rags and plastics.

The key benefit to the Narrandera Sewage Treatment Plant is that this technology reduces maintenance and increases efficiency of the treatment process. It is also a fully-automatic operation – the solids removed are collected in a bagging unit, which is hygienic.
