TWO PERFORATED BAND BELT SCREENS HUBER ESCAMAX® IN ORLANDO, FLORIDA

CASE STUDY

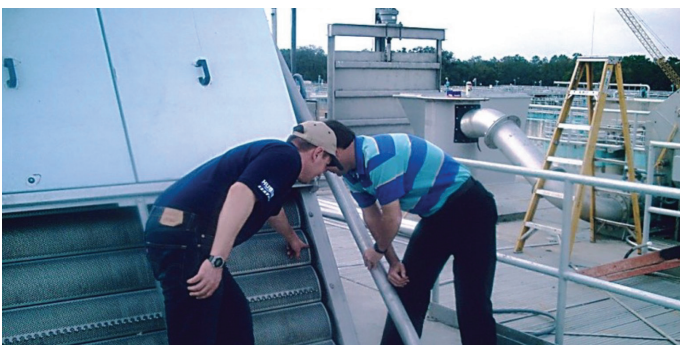
Ever increasing maintenance work on their prior screens prompted the plant management to look for screens requiring less maintenance and achieving better solids removal. They solicited offers from various screen manufacturers and specified screens with a capacity of 2,330 l/s (37,000 GPM), an installation angle of 60°, .6 mm diameter perforations, that is made of stainless steel material 1.4571 (SS 316L) and fully passivated in an acid bath.

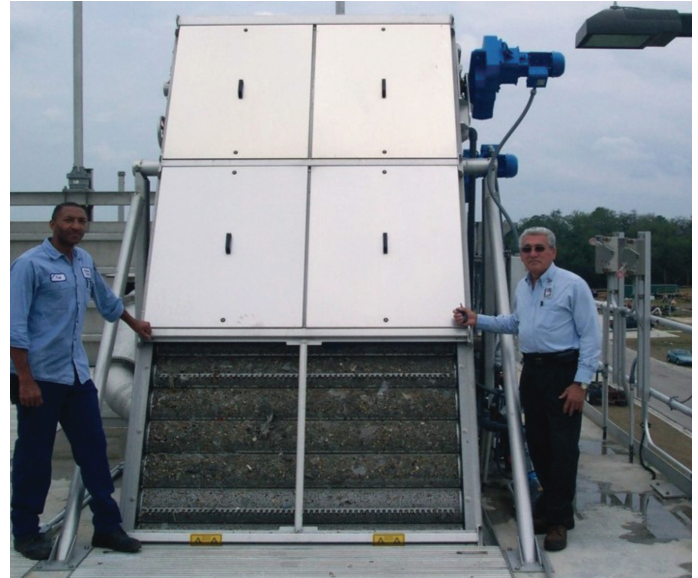
Since the Escamax® screens were put in operation, no maintenance has been needed. The city engineers were instantly impressed by the screens' high manufacturing quality and the operators now also praise their ease of operation and excellent performance. The perforated band elements of the EscaMax® are effectively cleaned with spray nozzles, followed by a rotating brush. Every fourth perforated screen elements is provided with rakes for reliable lifting and removal of coarse and bulky solids.

Two new wash-presses HUBER WAP 4 were also installed after the EscaMax® screens. Good equipment for screenings washing and compaction is especially important where screens with a very high capture rate are installed: their screenings contain a lot of fine inorganic as well as organic material that should be washed out and returned to the wastewater stream before the screenings are compacted. The city engineers and the operators realized that they could further improve reliability and performance of their mechanical pretreatment by installation of a pair of HUBER wash-presses; and they realized that they could save considerable disposal costs by doing so. Another advantage of good wash-presses is that they return organic material and its high BOD to the raw wastewater stream. In this way the BOD remains available for the treatment plant's denitrification process.
